## GENERAL DESCRIPTION:

The inspected property consisted of a two story wood-framed structure with brick veneer that was vacant at the time of the inspection. There were no major visual defects on the visible portions of the siding. The approximate temperature at the time of the inspection was 65 to 70 degrees Fahrenheit, and the weather was partly clear. The utilities were on at the time of the inspection with the exception of the gas meter. The buyers were present during the inspection.

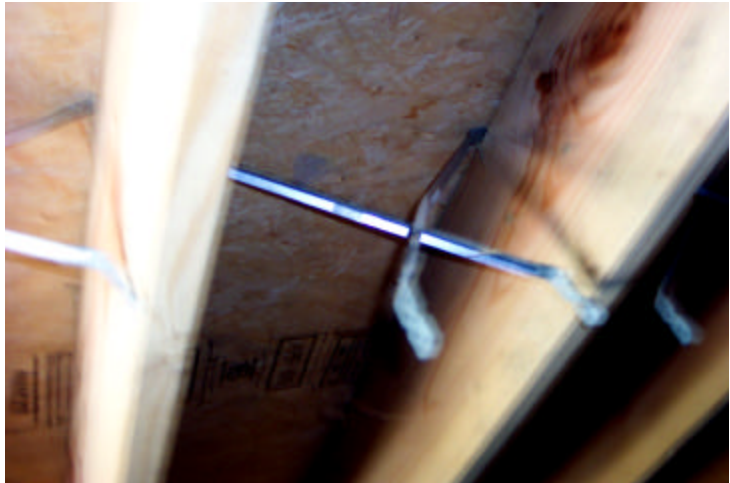
**Note the braces hanging down, some are wedged into place and not nailed.**

- 1. All of the metal cross braces between the floor joists were never nailed in place. These cross braces should be nailed in place to help prevent the joist from moving side to side. This will also add more structural stability to the floor system.**
